Upper Anterior Case Study

A biphasic matrix for true bone regeneration.
Built in membrane function, high graft stability.

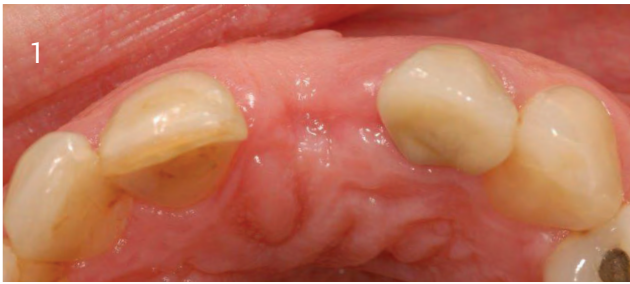
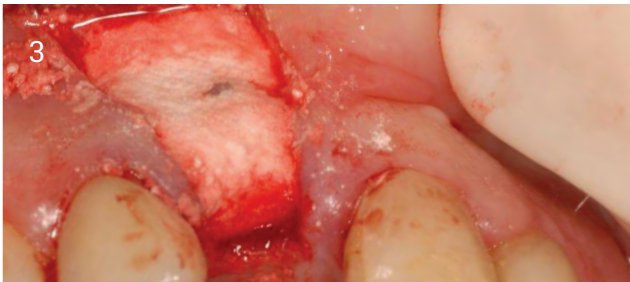
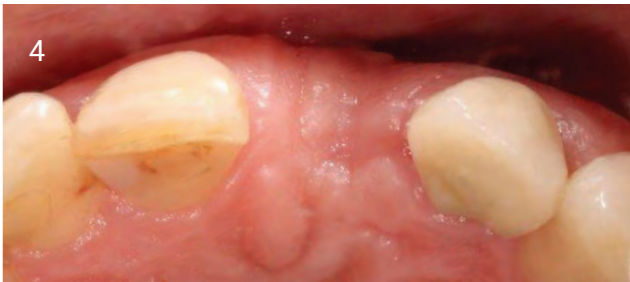
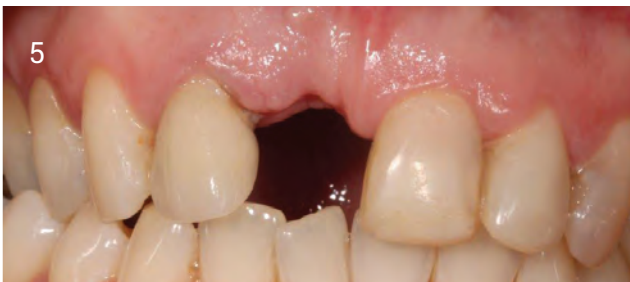
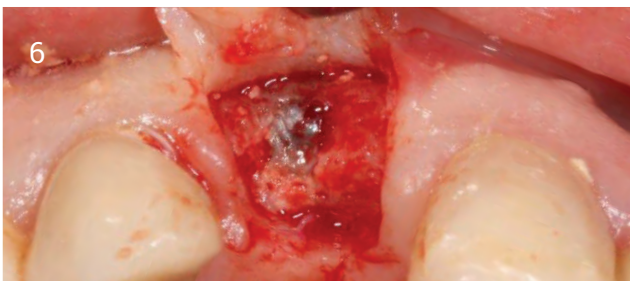
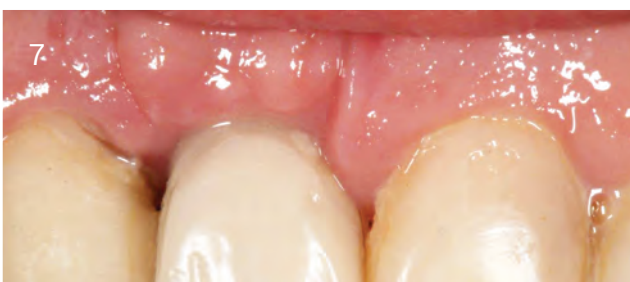
1. Buccal view pre-surgery. The UR1 was extracted due to lack of coronal tooth tissue available to crown. The root was dehiscant buccally at the apical portion, leaving the extraction socket not having buccal bone intact. The root was extracted, and the implant placed at 6 weeks.
2. Implant in position showing defect.
3. ethoss® placed.
4. Buccal view of healed site at 16 weeks.
5. Healed site at 16 weeks.
6. Exposure showing bone growth over implant no relief to preserve the gingival blood supply.
7. Fit of temporary tooth to allow gingival maturation.
